2016-17 Storm Season Preparation-Response-Damages

October 3, 2017
Castro Valley Rotary Club
by
Public Works Agency
Maintenance and Operations Department

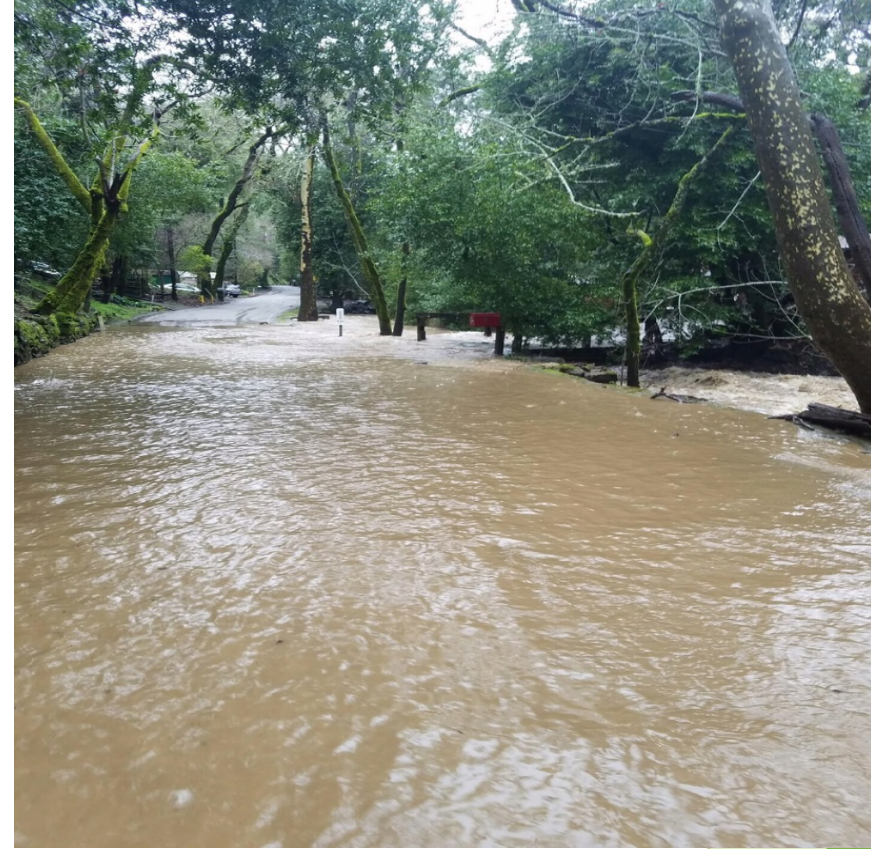
Altamont Pass Road, Livermore

Flooding

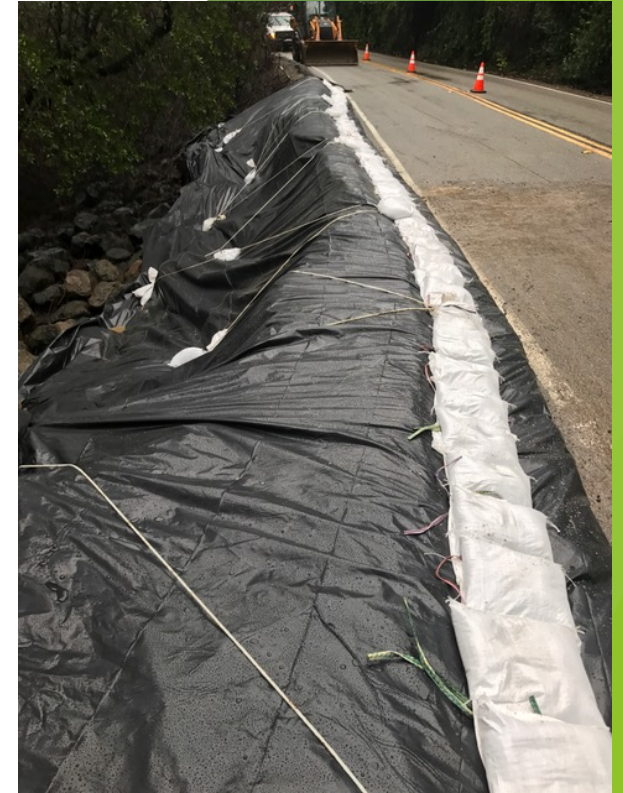
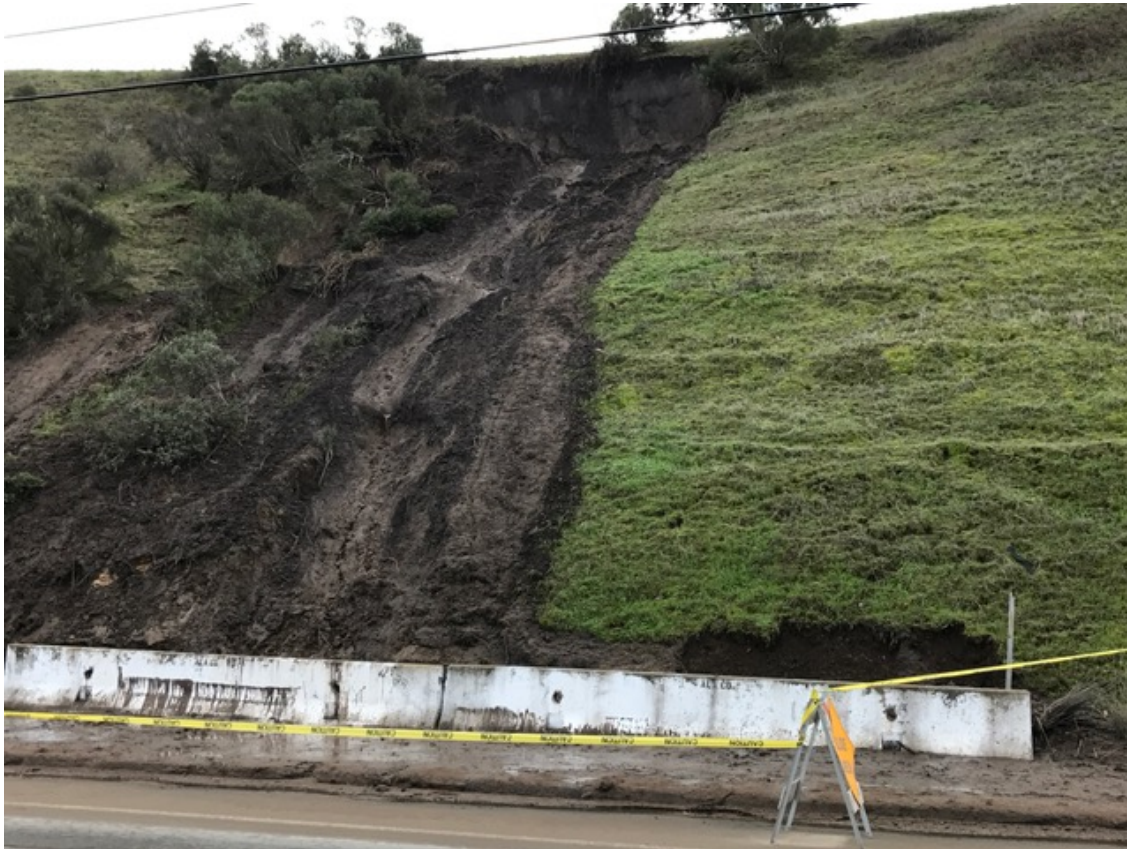
Norris Canyon Shoulder Slip-Out
Before and After

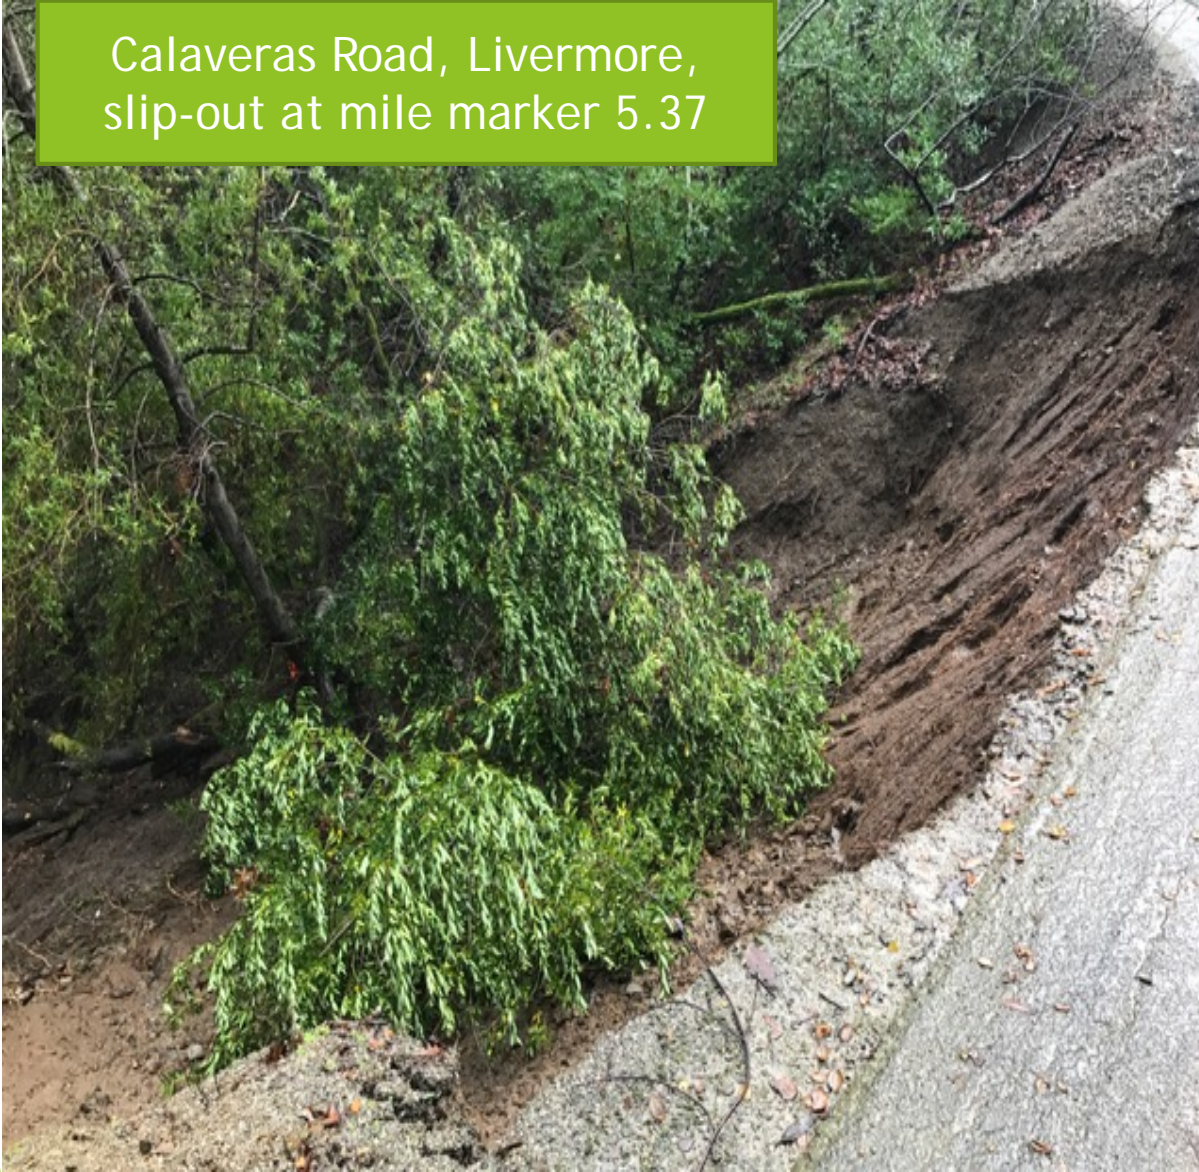
Calaveras Road, Livermore,
slip-out at mile marker 5.37

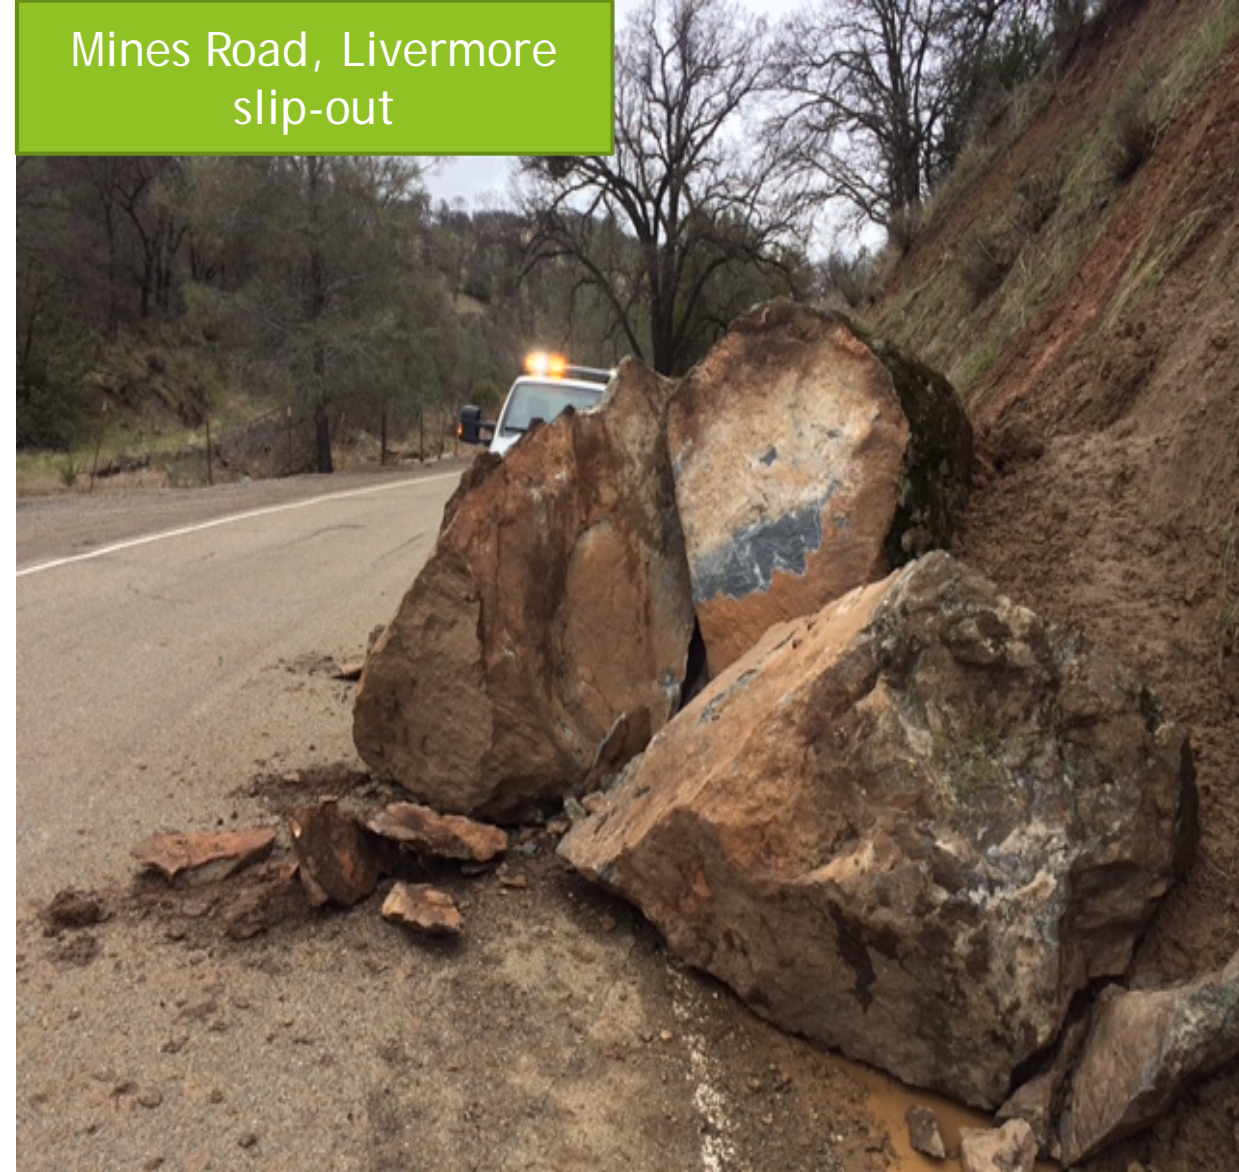
Mines Road, Livermore
slip-out

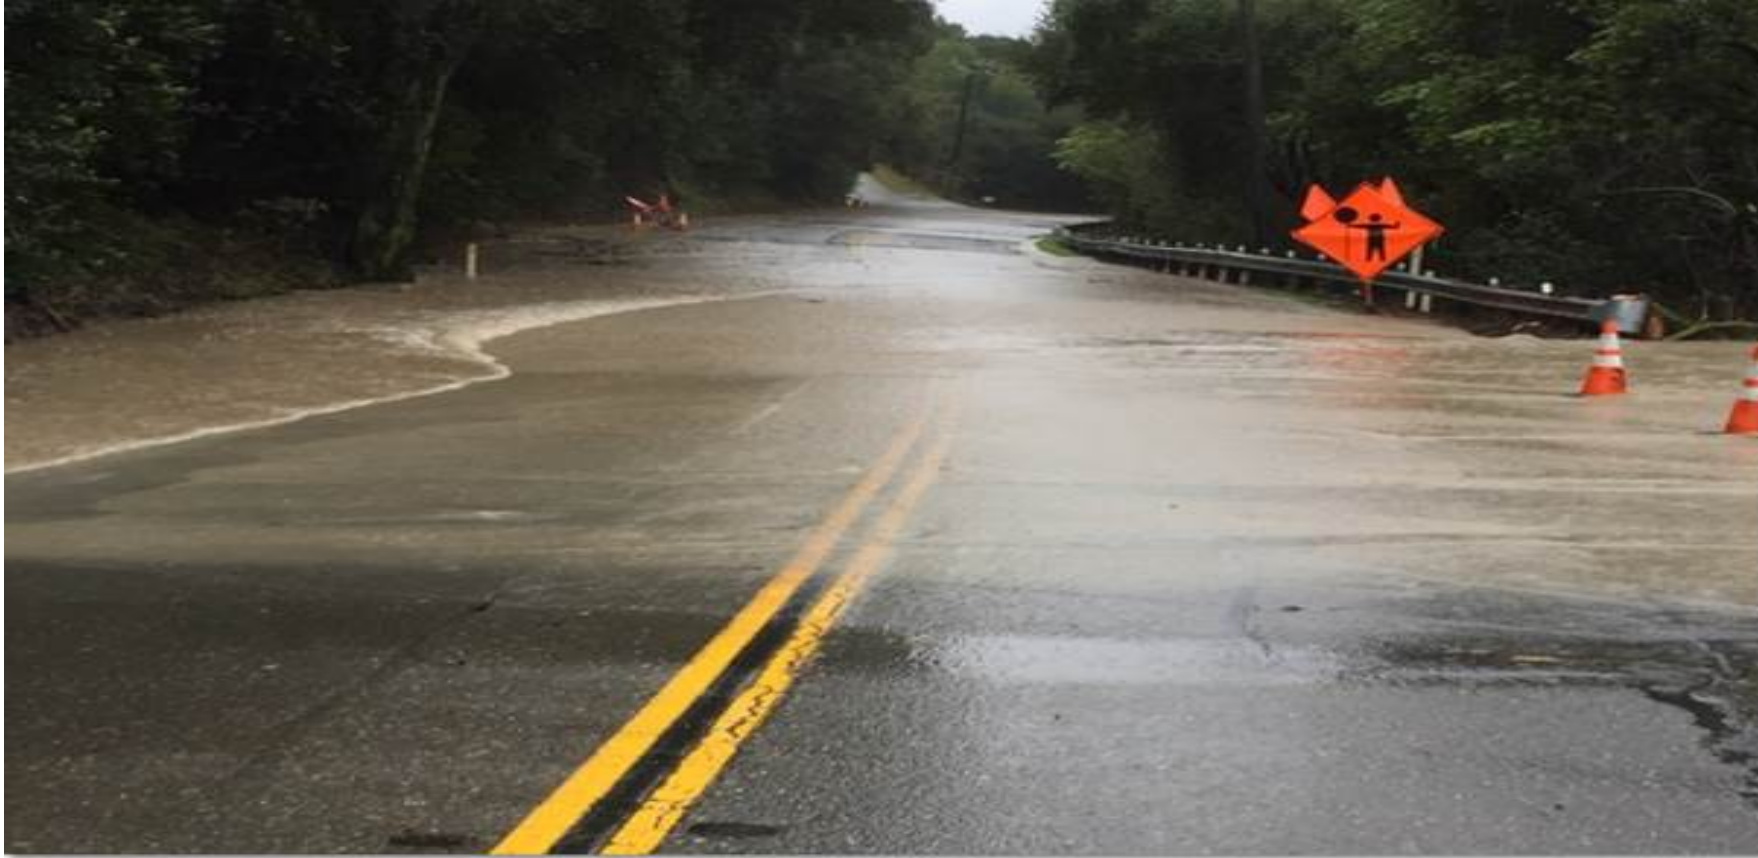
Crow Creek overflowed onto Crow Canyon Road at mile marker 6.3
Water diverted with newly installed muscle wall to keep water in the creek.

- Crow Creek overflowed its banks onto Crow Canyon Road in the vicinity of mile marker 6.3, resulting in a 12-hour road closure between Norris Canyon Road, Castro Valley, and Bollinger Canyon Road, San Ramon. ACPWA crews remained on scene for 48 hours, installing muscle wall to divert and contain creek water; then to monitor the situation.
- Downed tree and power lines, and a single vehicle incident in the vicinity of Coldwater Drive resulted in a 9-hour closure to all traffic between Greenridge Road and Norris Canyon Road.
- Multiple slip-outs along Crow Canyon Road between Greenridge Drive, Castro Valley, and Bollinger Drive, San Ramon, resulting in road closures between 2 and 4 hours in duration.

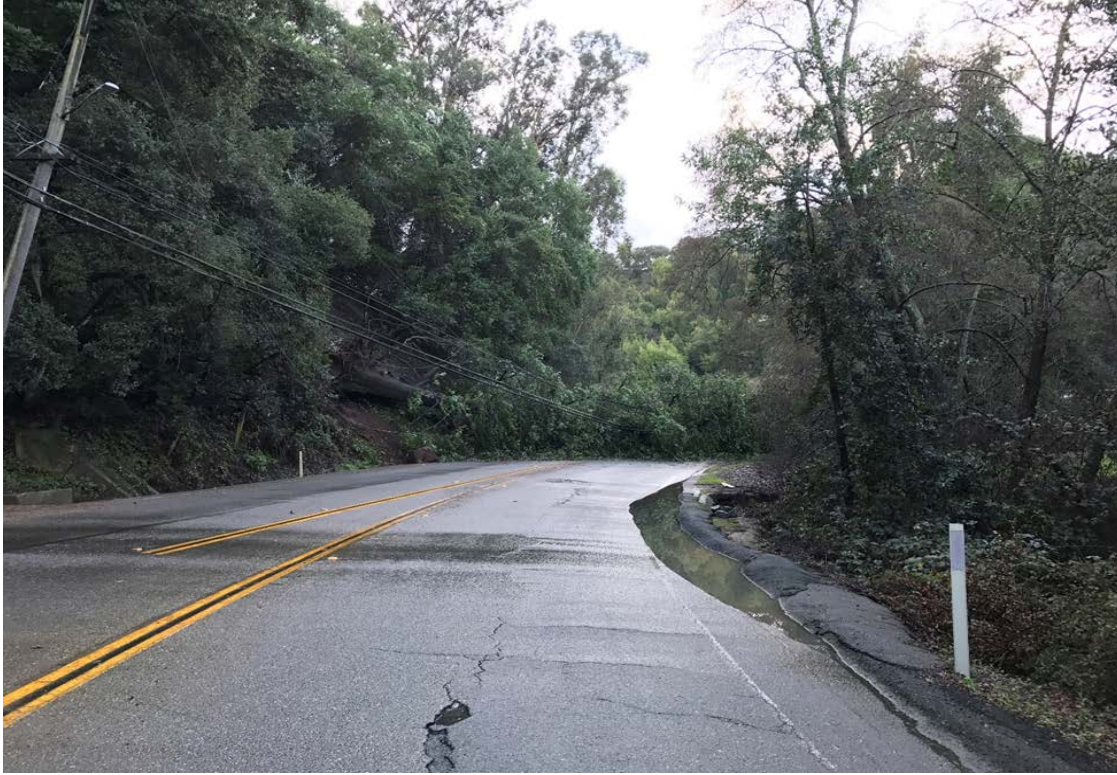
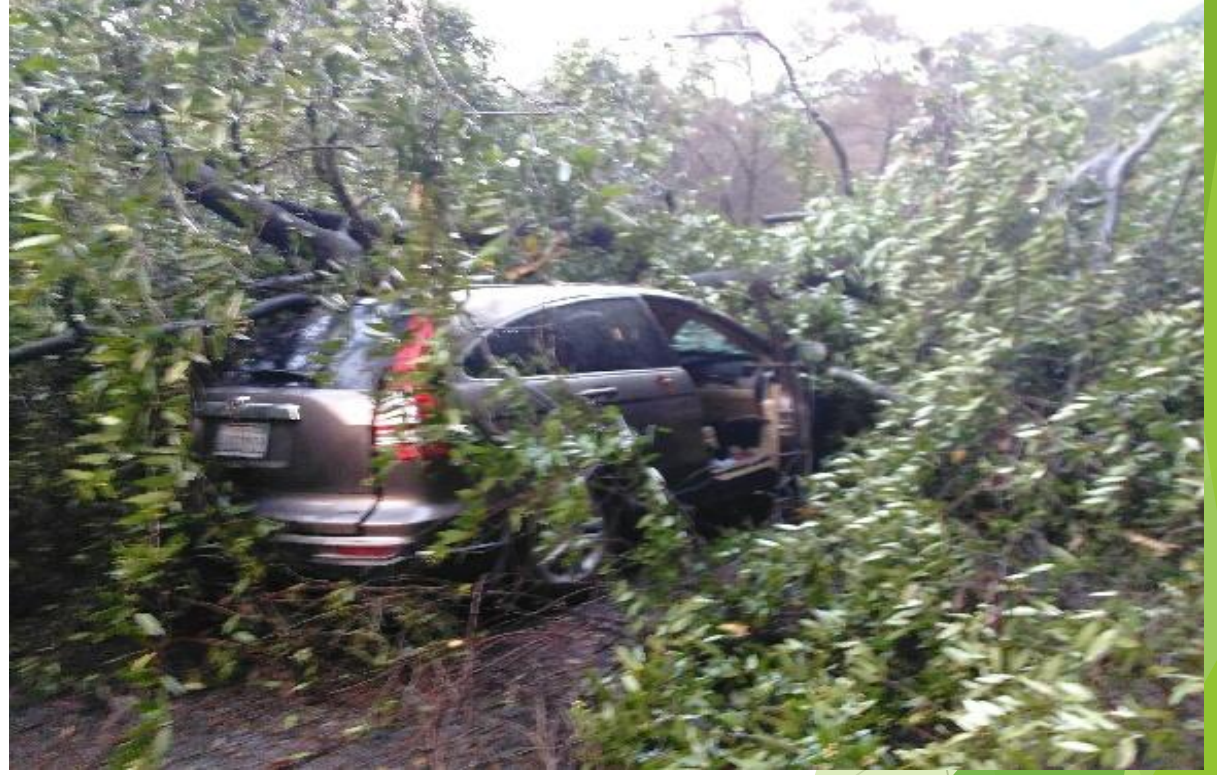
The large bay tree brought powerlines down in the vicinity of Coldwater Drive.
Tree removal and power restoration (by PG&E)
took approximately 4 hours.

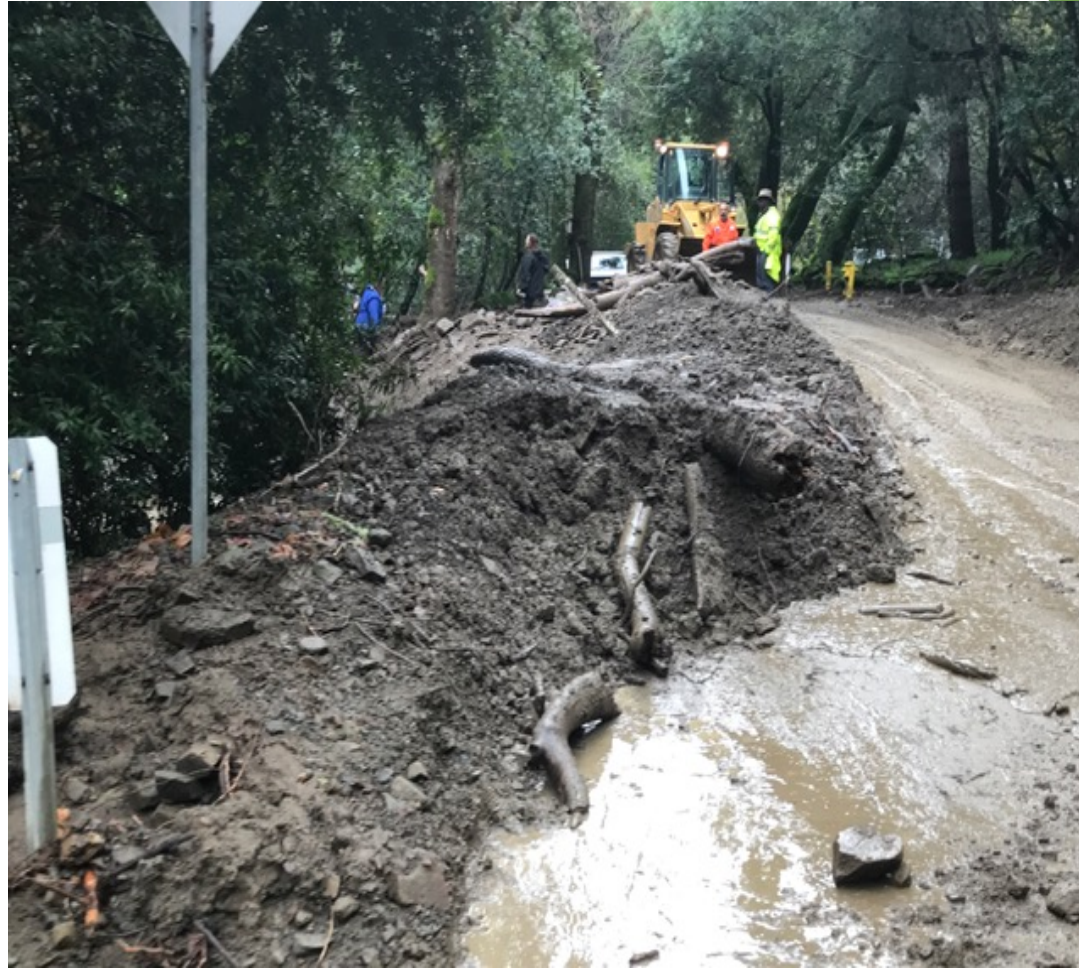
Flooding and creek debris
in the roadway

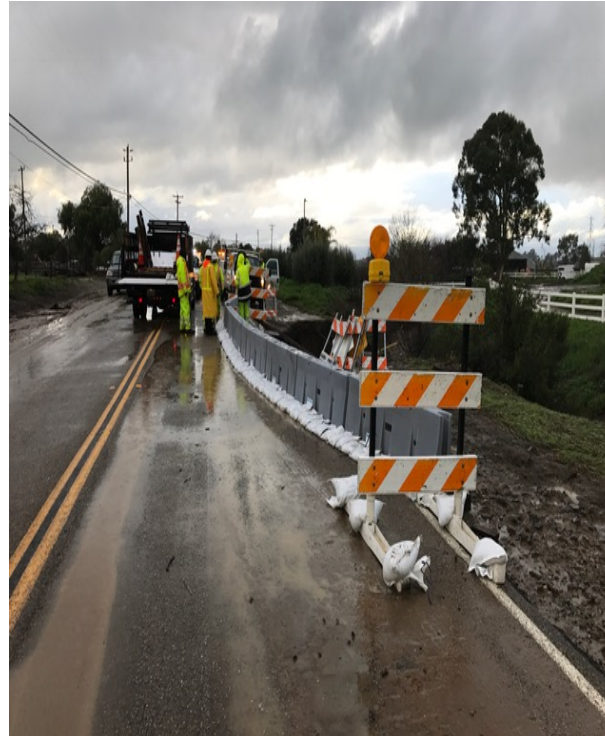
Tesla Road mm 3.63 slope failure along shoulder (before)

- A slope failure on Tesla Road, in the vicinity of mile marker 3.63 resulted in a road closure, between Cross Road, Livermore, and the Alameda/San Joaquin County line, for approximately 24 hours. Crews responded and installed temporary barricades while simultaneously repairing the slope. The road has remained open to all traffic.

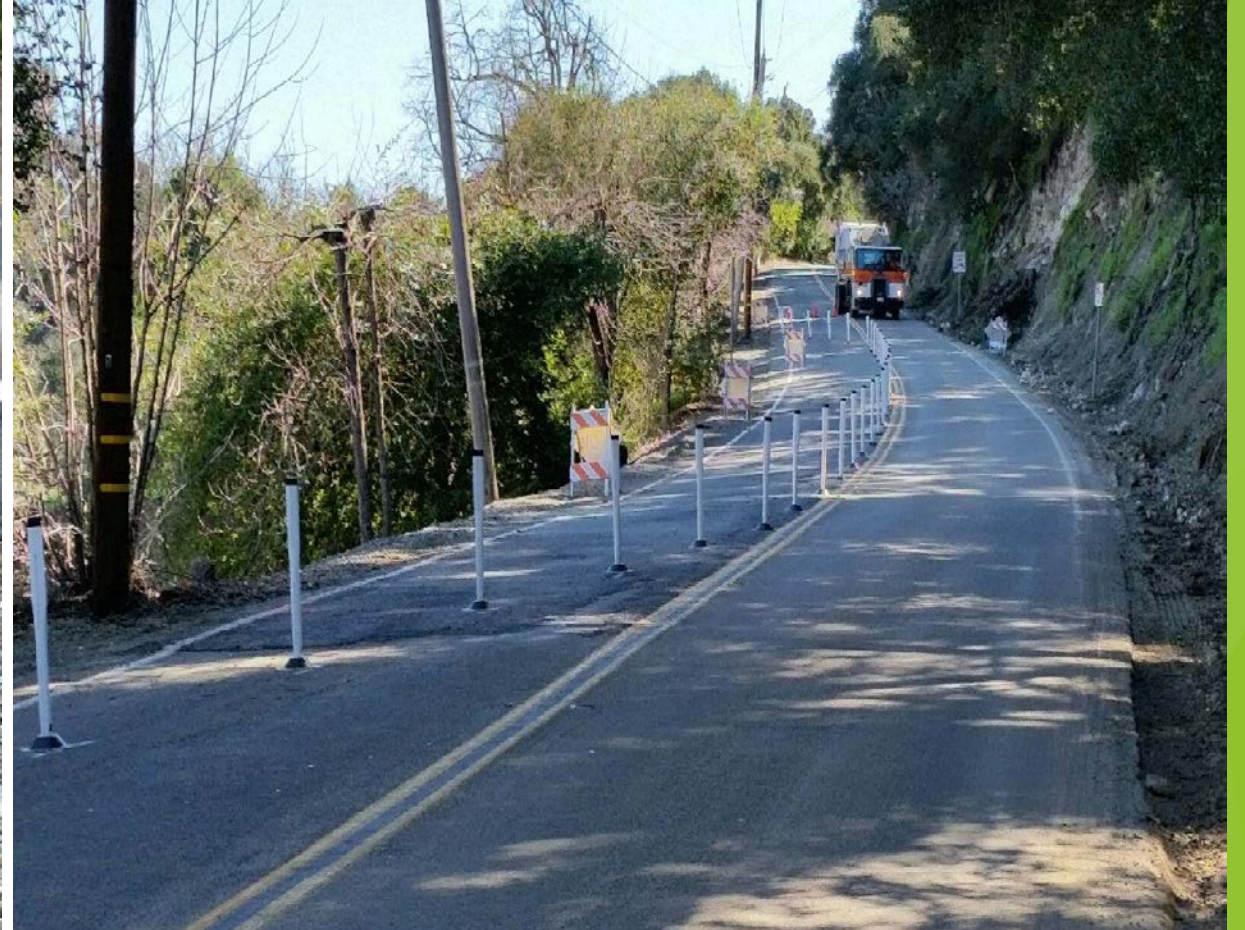
Foothill Road, Pleasanton
Slope Failure at mile marker 6.92
(before)

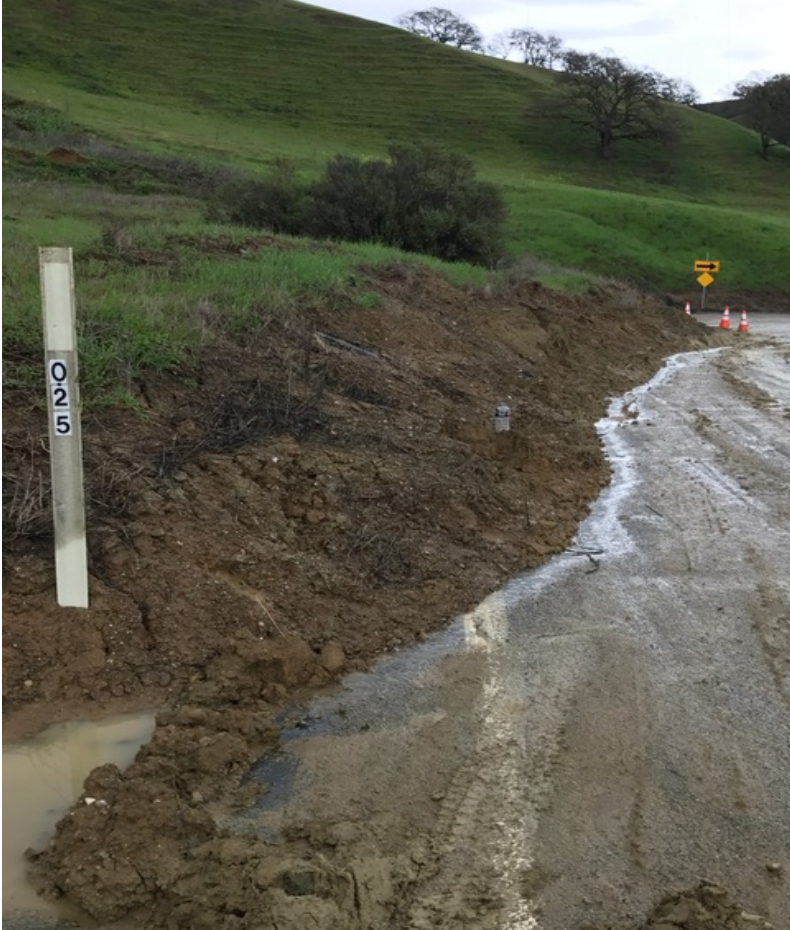
Koopman Road, Livermore
Slip-Out at mile marker 0.23
(before)

Foothill Road, Pleasanton
One-lane traffic control
(after)

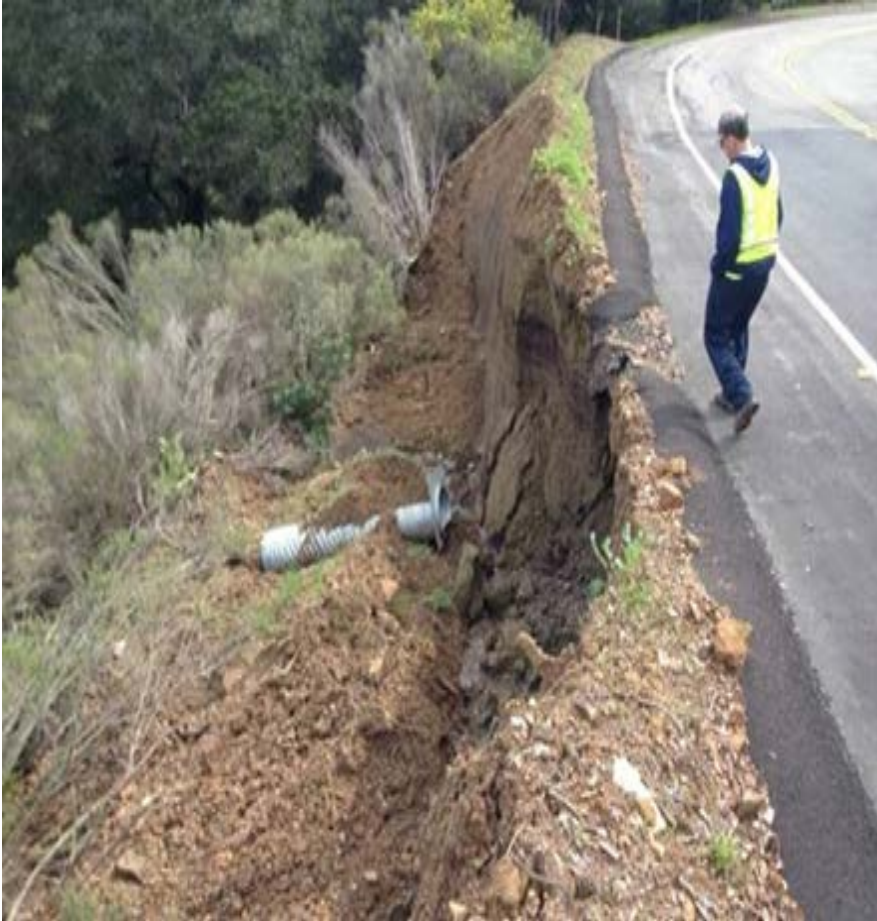
Redwood Road, Castro Valley
Slip-out at mile marker 7.38
(before)

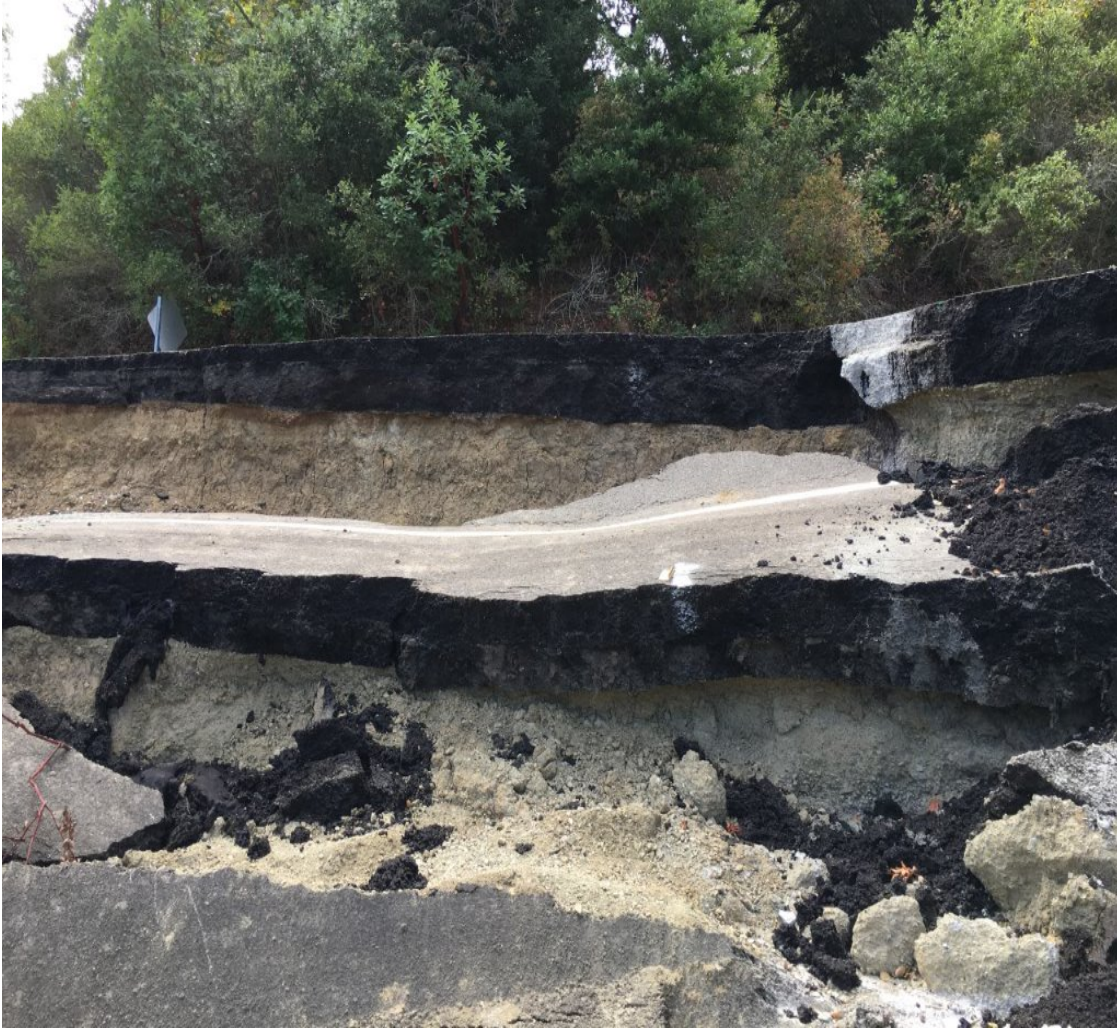
Redwood Road MM 7.38

DOWN SLOPE VIEW OF SLIP OUT

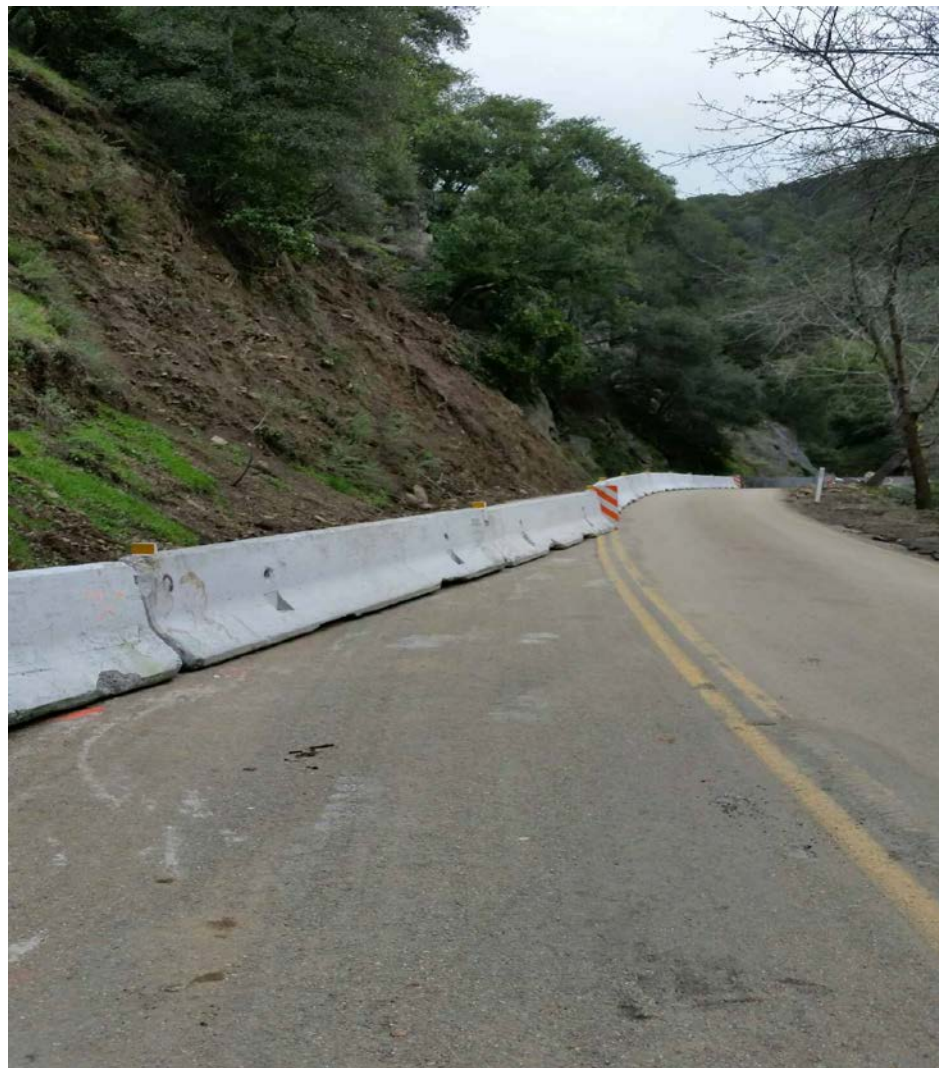
Palomares Road, Castro Valley,
mile marker 8.73 (before)
