# A Close Look at the Pivot Transfer

## Altering Technique to reduce injury risk during patient transfer

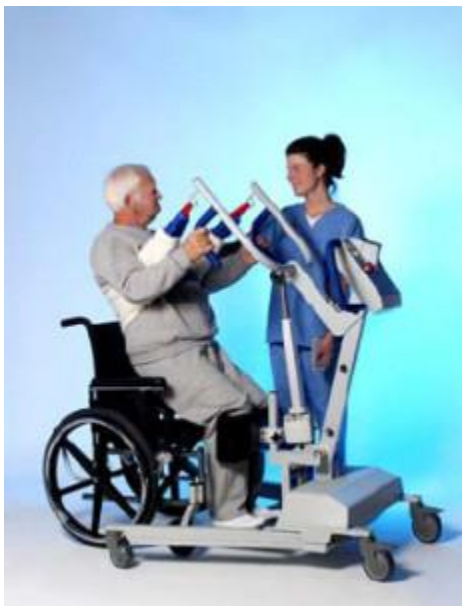
After the patient is sitting upright, a band harness is placed around the lower trunk. The patient places his or her feet on the base of the lift; the lift is then pulled up close to the patient and, with the lift arms lowered, the band harness is attached to the sit/stand lift. As the caregiver activates the electronic hand control, it begins to raise the lift arms that the patient's band harness is attached to and, as the lift arms rise, the patient is brought from a sitting to a standing position with minimal to no exertion by the caregiver.

Sit/Stand patient transfer equipment is an alternative to the pivot transfer that allows patients to bear weight while it facilitates safe and proper joint alignment and increases protection and comfort (see photo, right). This equipment is for patients with at least 30% to 60% weight-bearing status and the ability to hold on with at least one hand, or two hands if a simple band harness is used, and who are cooperative with the use of the equipment and have the endurance to tolerate weight bearing and upper extremity use.

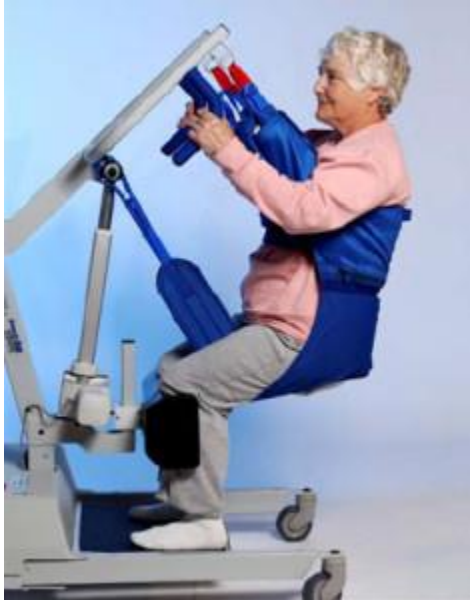
The sit/stand lift is for patients with at least 30% to 60% weight-bearing status and the ability to hold on with at least one hand, or two hands if a simple band harness is used.
